Rushmore Inspection Services

Your Property Inspection Report

1234 Anywhere St, Rapid City, SD 92103 Inspection prepared for: John & Jane Doe Date of Inspection: 9/4/2025 Time: 9:00 - 11:30 AM Age of Home: 2003 Size: 1,728 sq ft Weather: 60 degrees. Rain in past 24 hrs.

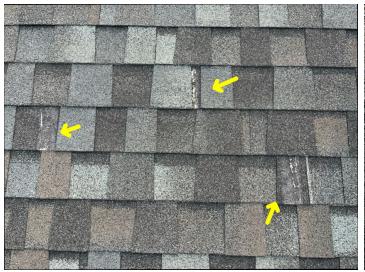
- No major system safety or function concerns noted at time of inspection, except as noted below in red.
- Widespread shingle damage noted. Recommend evaluation by licensed roofing company.
- Exposed nails on roofing material. Recommend sealing all fastener heads.

Shingle damage on West facing roof.

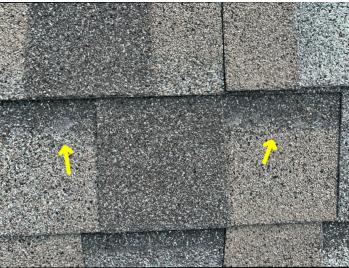
Shingle damage on West facing roof.

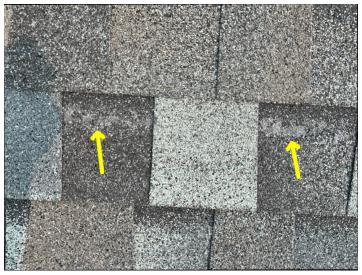
Shingle damage noted on South side of roof.

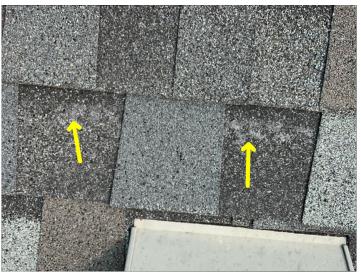
Shingle damage noted on South side of roof.

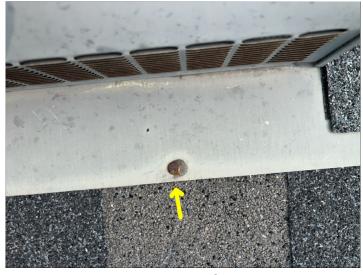
Exposed nails on roofing material.

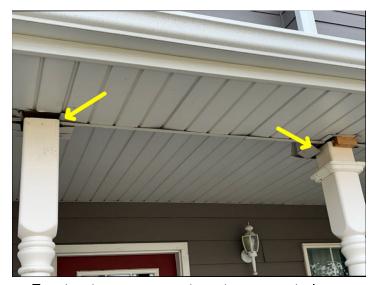
- Support posts at front patio appear to have settled and are no longer supporting roof above. Recommend evaluation by licensed contractor.
- Large crack on South side of front patio. Appears to be settling.

Front entrance support posts appear to have settled.

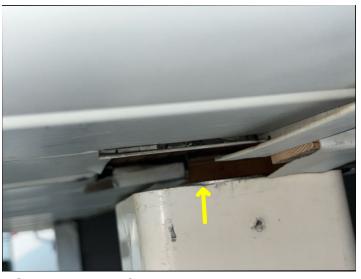
Support post at front entrance appears to have settled. Not supporting roof above.

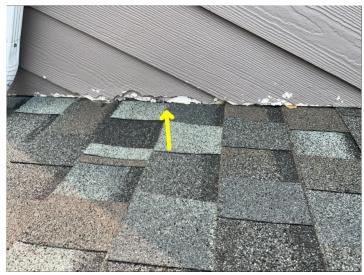
Siding damage on East side of home above garage roof.

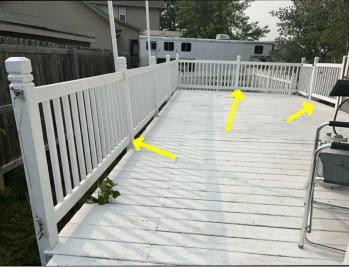
- No major system safety or function concerns noted at time of inspection.
- Although rails are not required for steps with drop offs less than 30", consider your own personal needs and safety and those of your family and guests.
- Deck Substructure Inspection excluded, due to limited access because of low height or obstructions.
- Deck railing loose. Recommend re-anchoring.

Railings loose around entire deck.

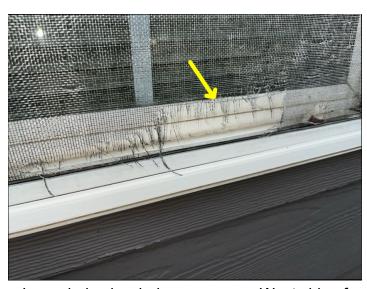
Large holes in window screen on West side of garage.

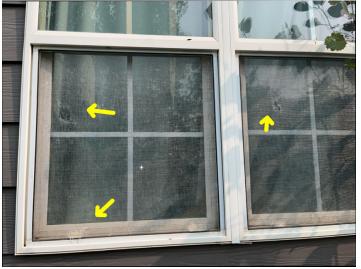
Large holes in window screens on South side of Holes in window screen on upper level window on home. South side of home.

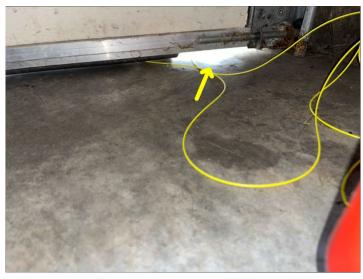
Air and light entering at corners of vehicle garage door.

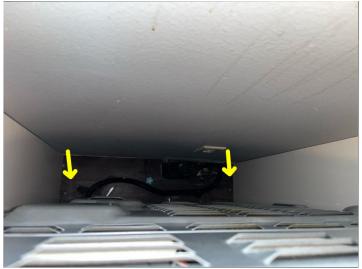
No anti-tip brackets installed behind range.

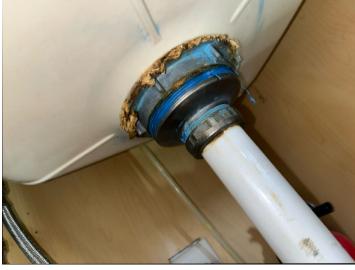
Previous repairs noted below kitchen sink. Dry at time of inspection. Monitor.

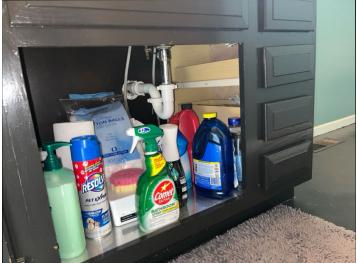
Vanity door is missing.

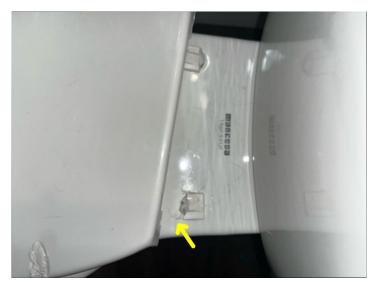
Toilet seat cover broken.

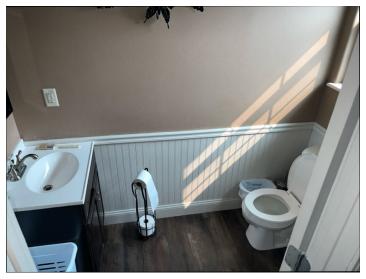
Toilet anchor bolts should be capped for safety.

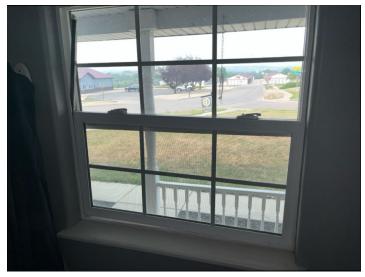
Window in front entryway does not stay open.
